Contract Report ITL-92-5  
December 1992

# Engineering Reliability of Navigation Structures, Supplement No. 1

*by Thomas F. Wolff, Weijun Wang, Michigan State University*

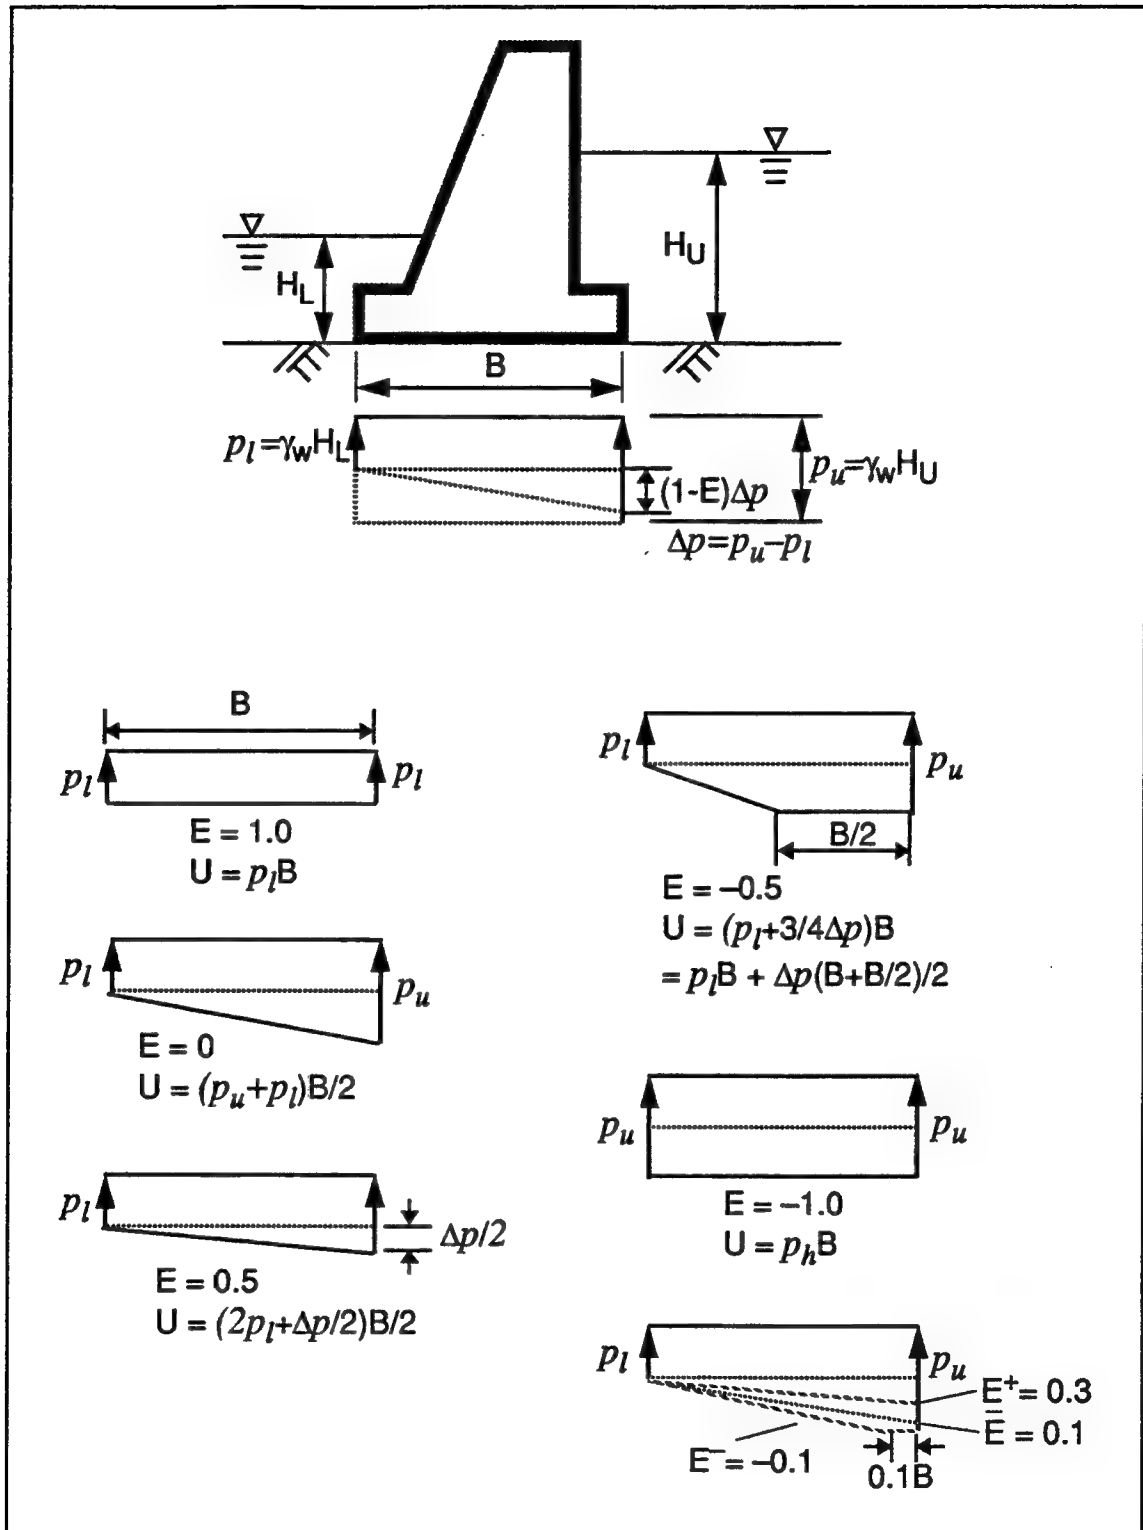
Figure 2.1 Definition of Uplift Parameter,  $E$

$H_U$  is the pressure head at the upper end of the monolith base,  
 $H_L$  is the pressure head at the lower end of the monolith base,  
 $B$  is the width of the monolith base, and  
 $\gamma_w$  is the unit weight of water

Defining  $E$  as a drainage efficiency parameter that varies linearly from 0.0 for the case of no foundation drains to 1.0 for the case of perfect foundation drains, the above two equations can be generalized as:

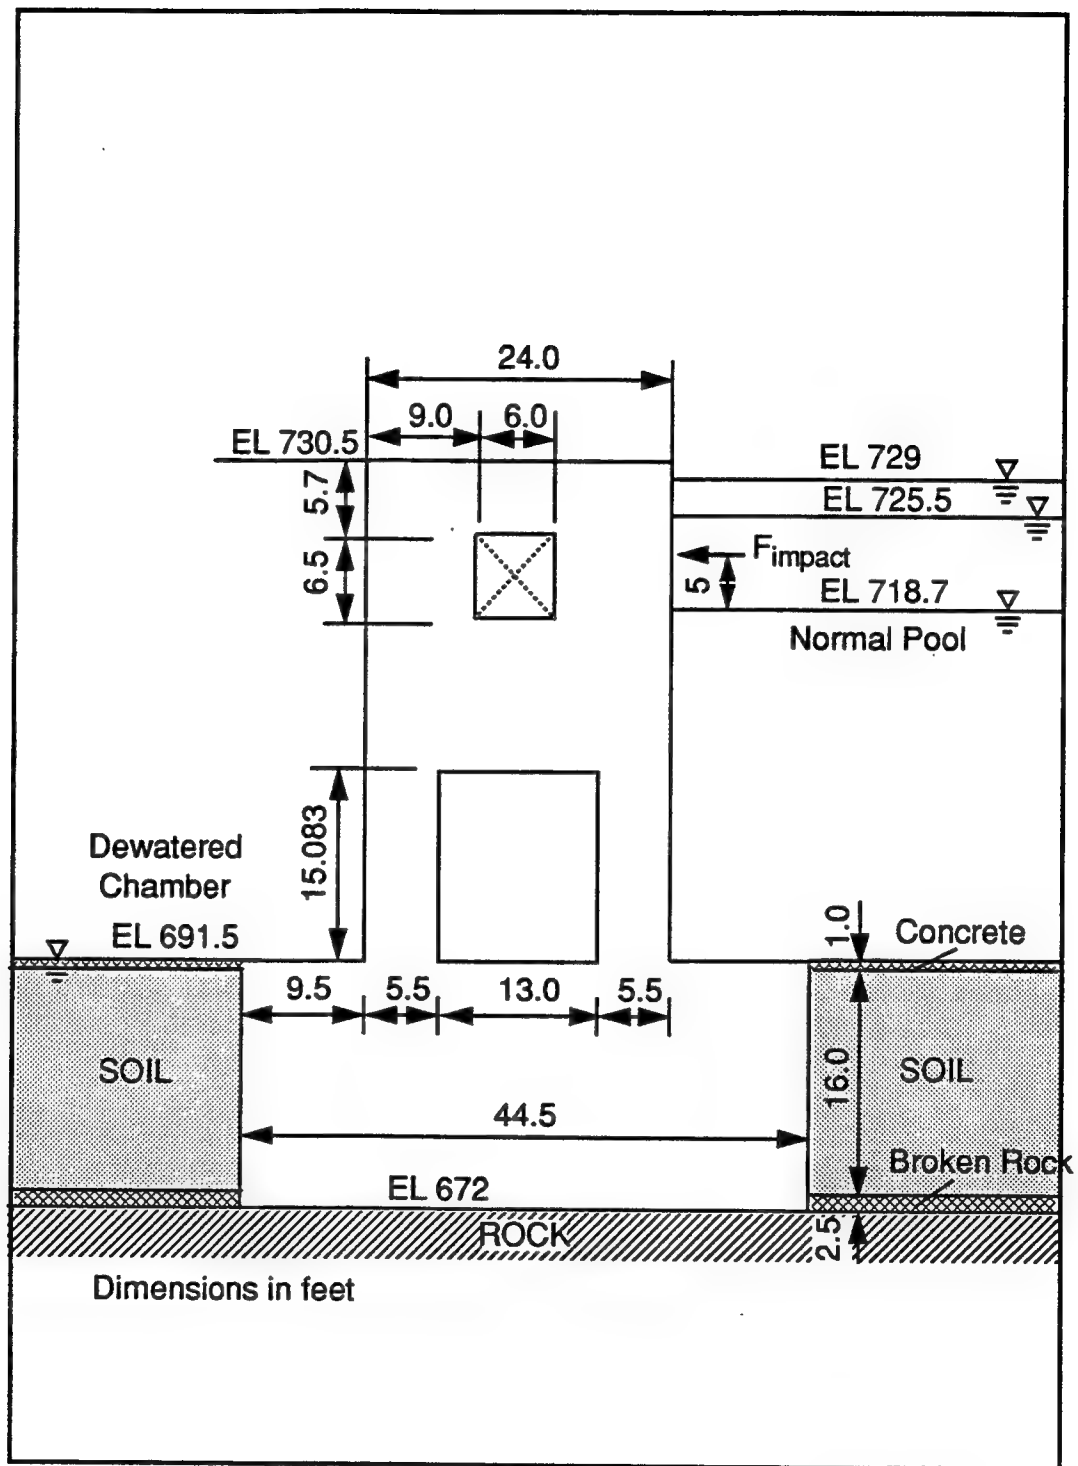
Figure 2.2 Locks & Dam No.2, Monolith M-16, Cross-Section

To assess the effects of the parameter  $E$  on the reliability of monolith M-16, the cross-section shown in figure 2.2 was analyzed. The random variables were assigned the

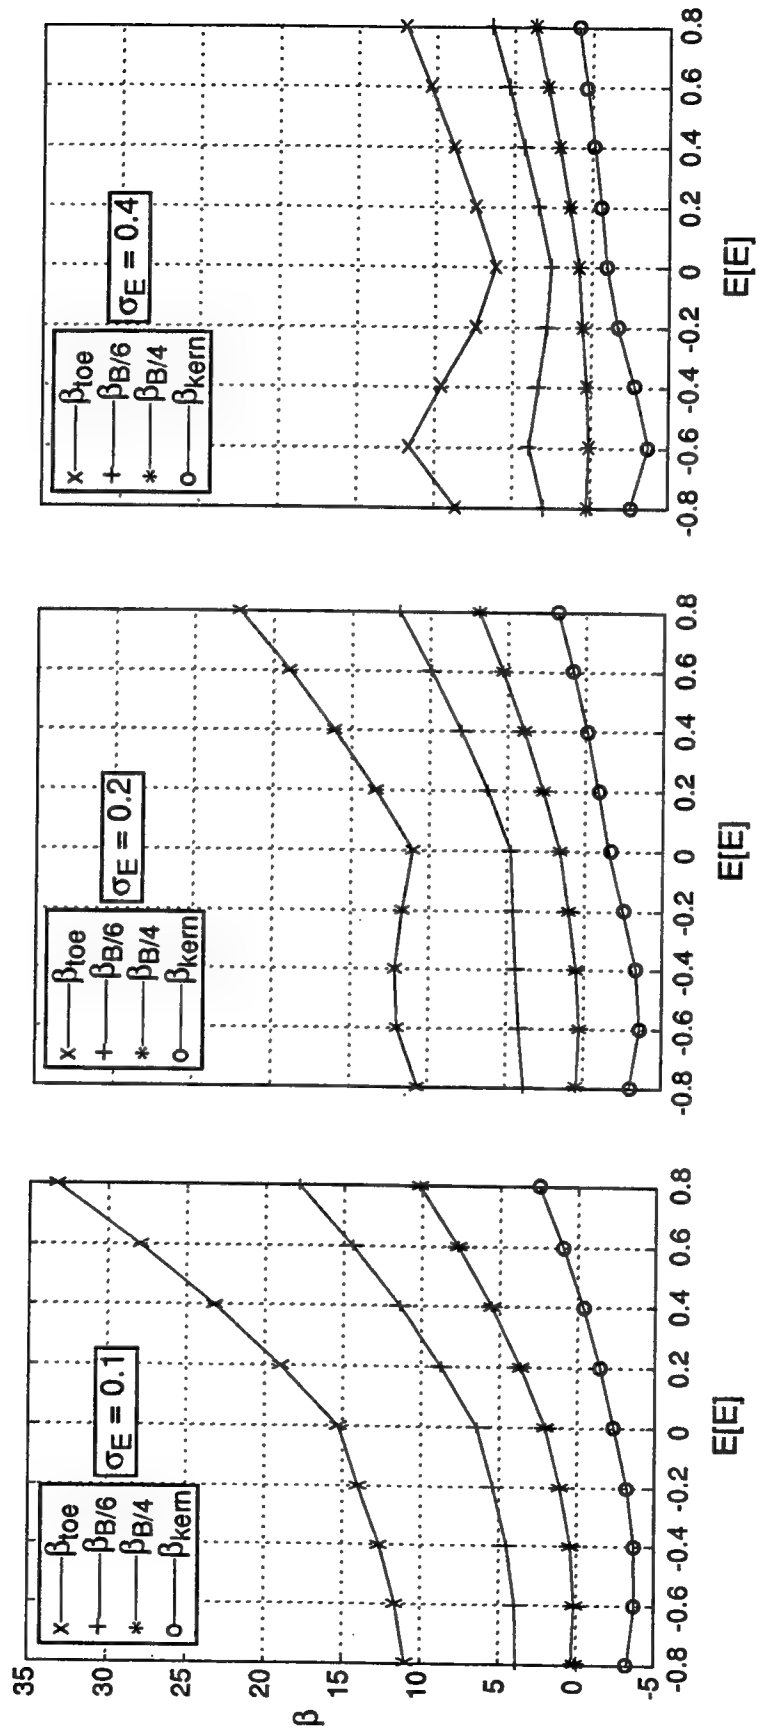
Figure 2.4 Locks and Dam No. 2, Monolith M-16, Resultant Location Analysis  
 $\beta$  versus  $E[E]$  with  $\sigma_E = 0.1, 0.2$  and  $0.4$

Figure 2.6 summarizes the variation of  $\beta_{\text{toe}}$  vs  $E[E]$  from the three parts of Figure 2.4 on one plot, and Figure 2.7 summarizes the variation of  $\beta_{\text{toe}}$  vs.  $\sigma_E$  from three parts of figure 2.5 on one plot. Again, it is noted that the lowest value of  $\beta$  occurs for  $E[E] = 0$  and  $\sigma_E = 0.4$ ; the uncertainty as to whether the entire base is in compression results

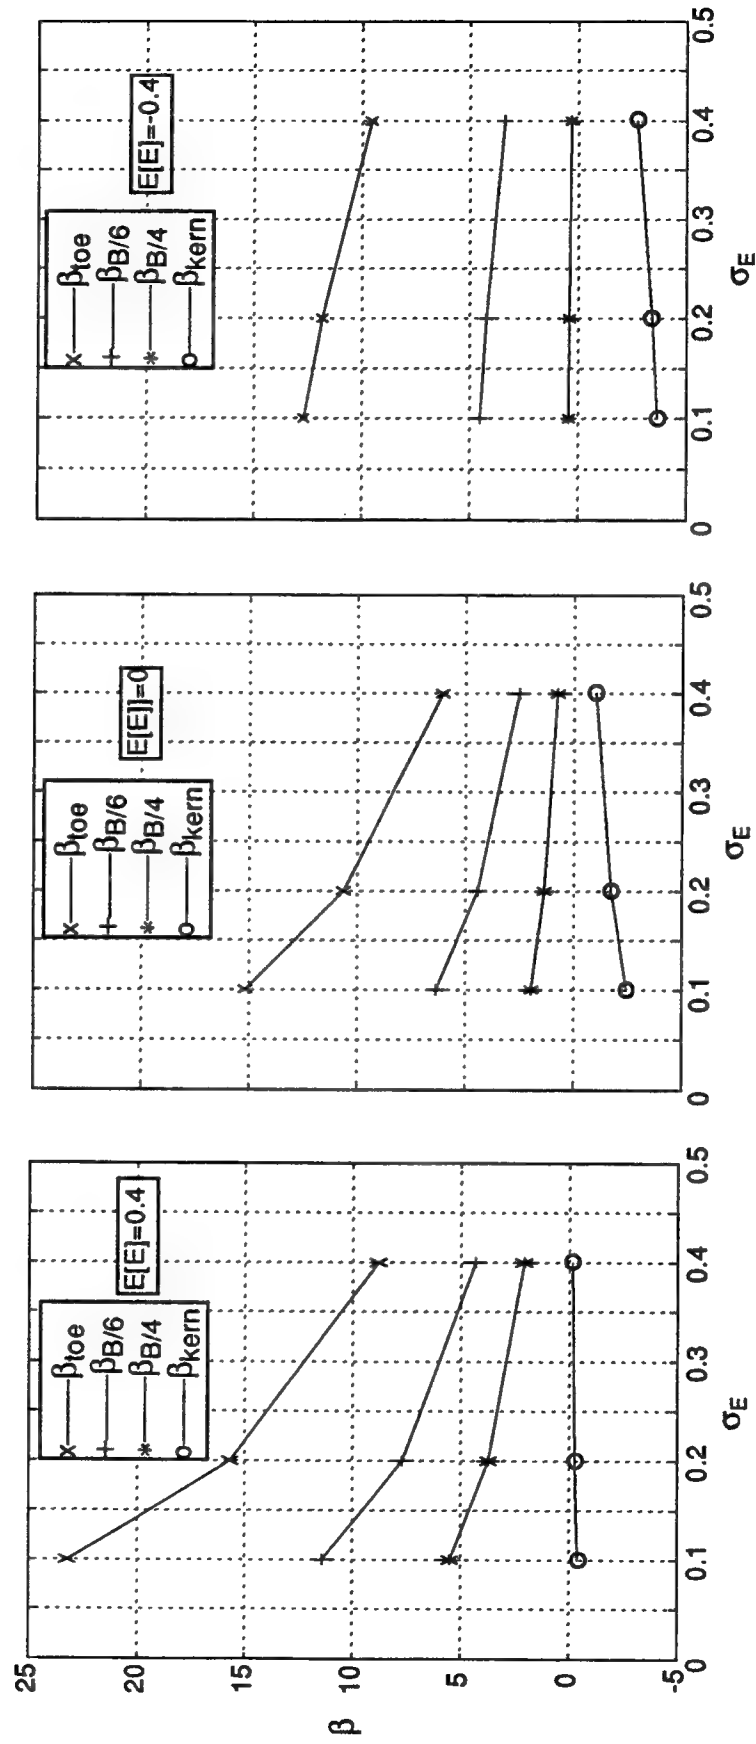
Figure 2.5 Locks and Dam No. 2, Monolith M-16, Resultant Location Analysis  
 $\beta$  versus  $\sigma_E$  with  $E[E] = 0.4, 0$  and  $-0.4$

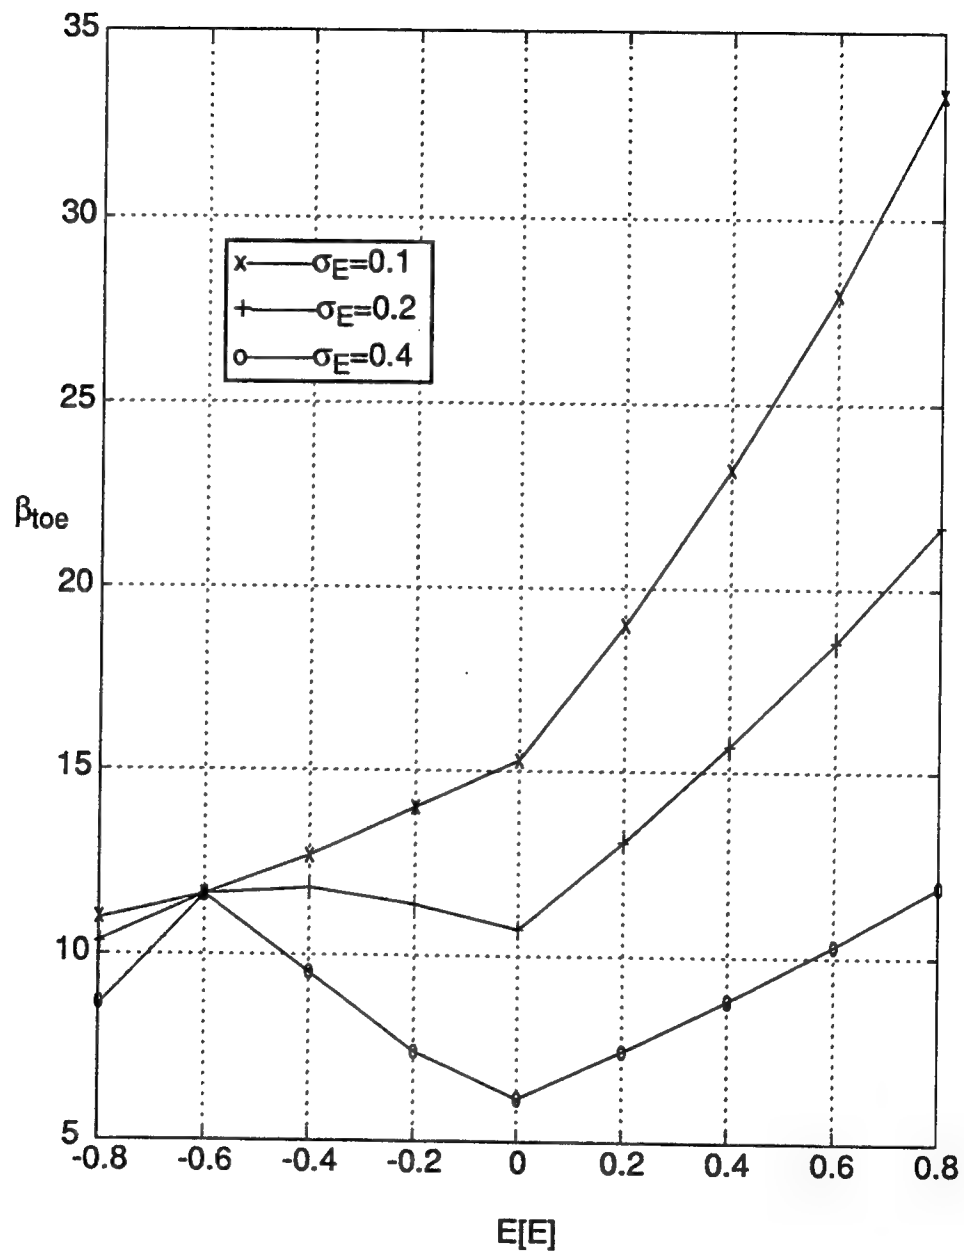
Figure 2.6 Locks and Dam No. 2, Monolith M-16, Resultant Location Analysis,  $\beta_{toe}$  versus  $E[E]$

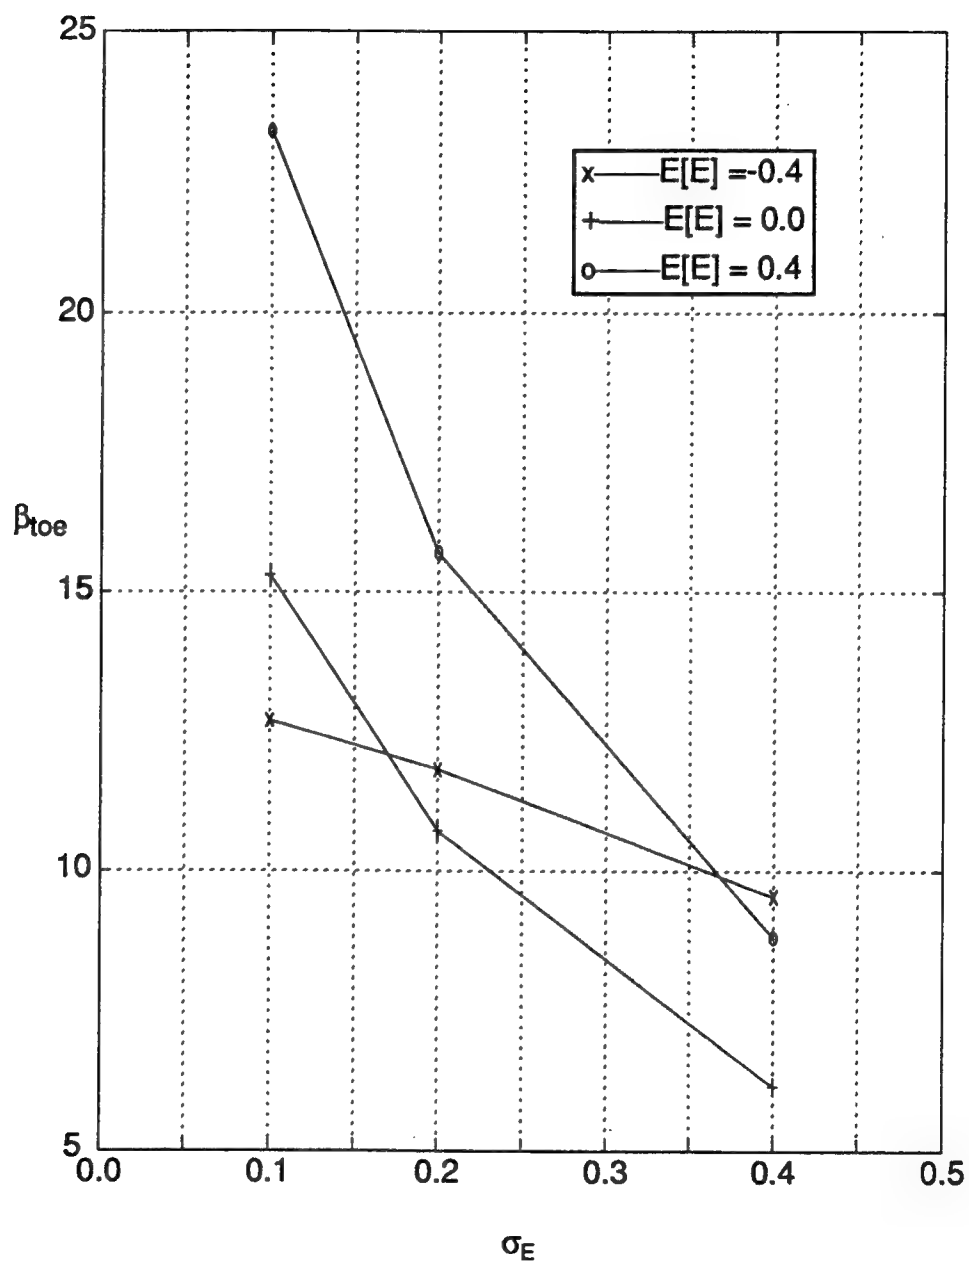
**Figure 2.7 Locks and Dam No. 2, Monolith M-16, Resultant Location Analysis,  $\beta_{toe}$  versus  $\sigma_E$**

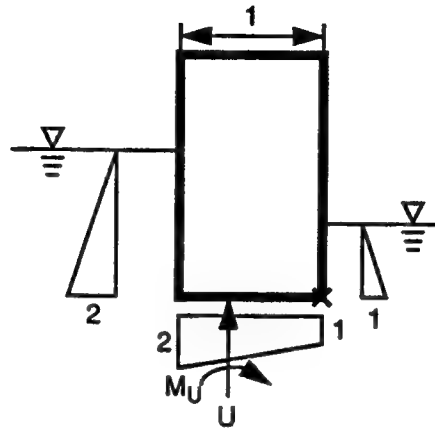
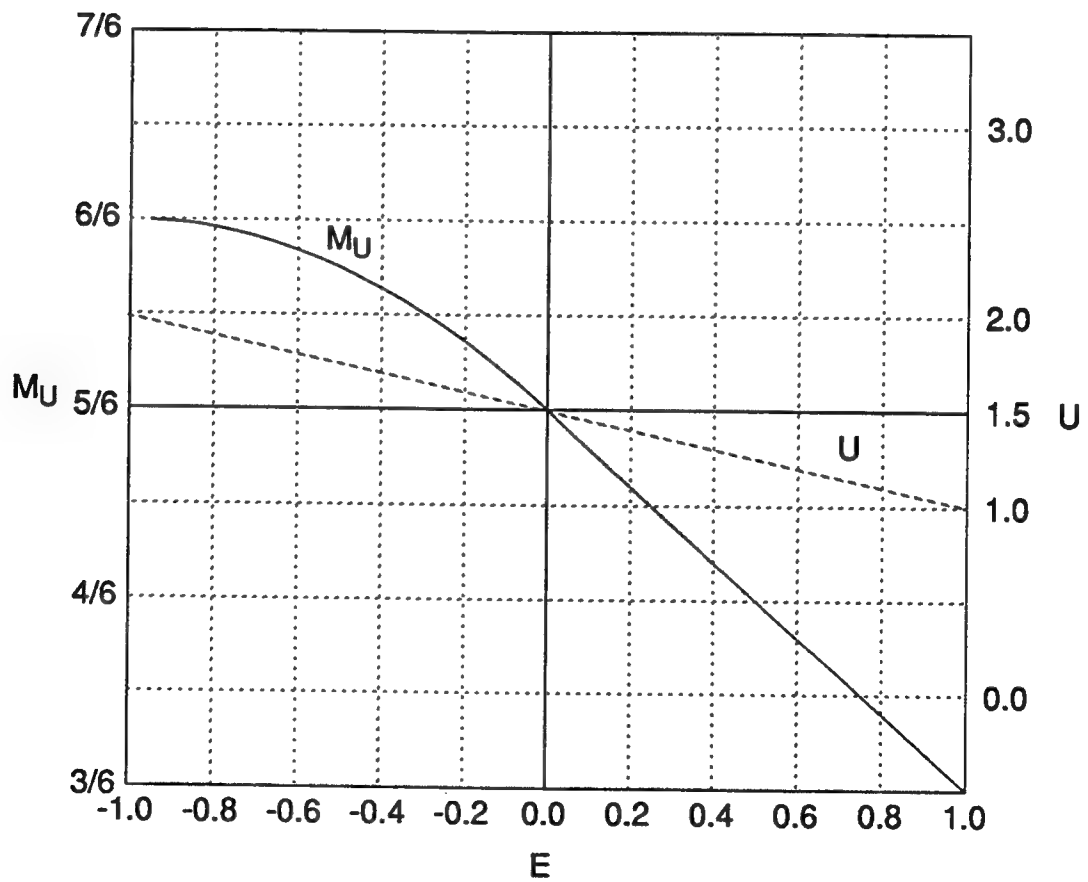
Figure 2.8 Uplift Force  $U$  and its Moment  $M_U$  versus  $E$  Factor

The reason for the greater sensitivity of the reliability index for positive values of  $E$  than for negative values of  $E$  is illustrated in figure 2.8. As  $E$  increases from 0.0 to 1.0, the uplift force  $U$  and net overturning moment  $M$  decrease linearly, as the point of application of  $U$  remains constant. As  $E$  decreases from 0.0 to -1.0, the uplift force increases linearly, but the moment increases at a decreasing rate as the point of application moves toward the center.

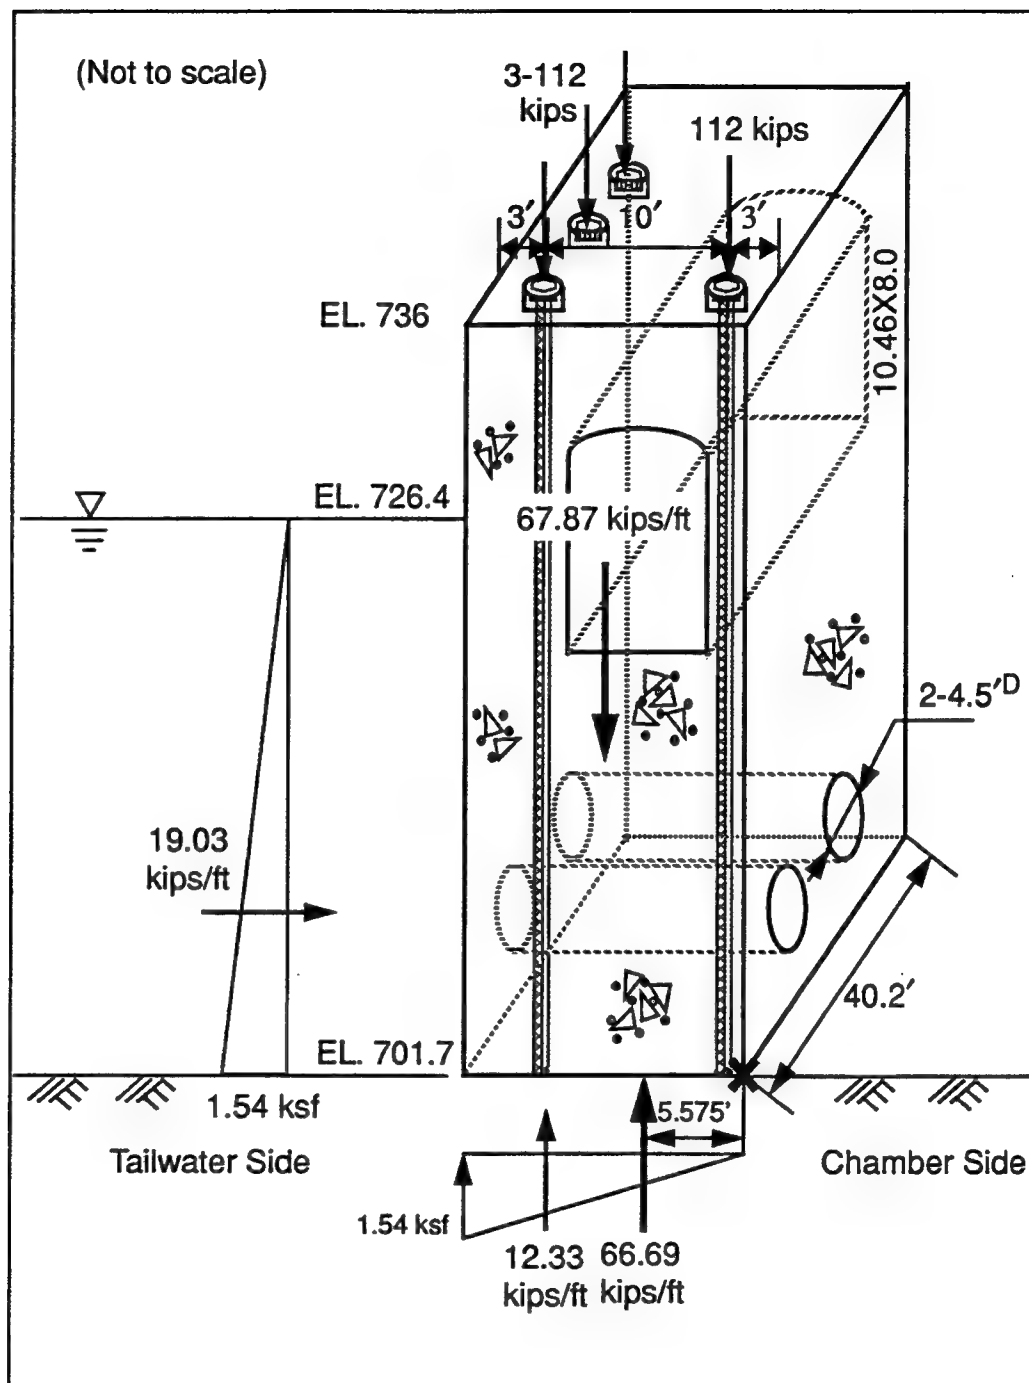
**Figure 3.1 Locks and Dam No. 3, Monolith M-20, Resultant Location  
Analysis, Maintenance Condition (A), 3+1 Anchors**

The geometry of monolith M-20 is illustrated in the free-body diagram in Figure 3.1. The planned anchor installation called for 6 anchors, four on the tailwater side and two on the chamber side. However, only three were satisfactorily installed on the tailwater side, and only one was satisfactorily installed on the chamber side.

analyses, the reliability index was calculated for  $\beta_{\text{toe}}$ ,  $\beta_{\text{FS}}$ , and  $\beta_{\text{CD}}$ . Free body diagrams for the maintenance (A) condition with and without anchors are shown on Figures 3.1 and 3.2, respectively, and example calculations for the mean value analyses of these conditions are shown in Tables 3.2 and 3.3. Results of the analyses are shown in Tables 3.4 and 3.5. Comparison of the results for  $\beta_{\text{FS}}$  and  $\beta_{\text{CD}}$  indicate similar trends. As would be expected, the reliability increases as the tailwater level during dewatering decreases and the reliability increases as the number of functional anchors increases. For similar pool levels, values are typically lower than found in the previous report, apparently due to consideration of the parameter E.

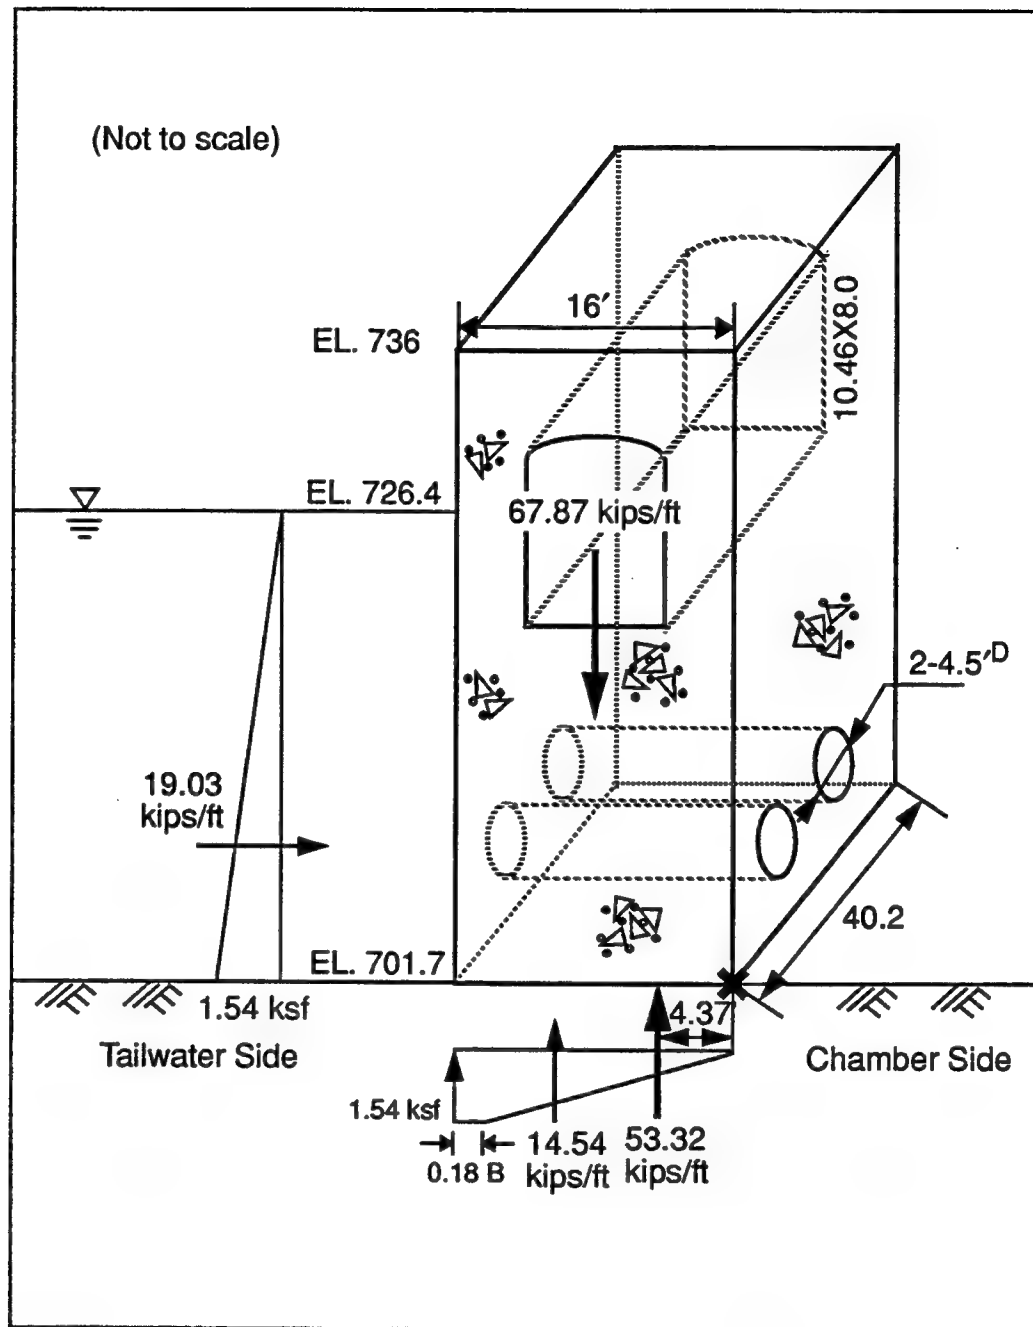
**Figure 3.2 Locks and Dam No. 3, Monolith M-20, Resultant Location Analysis, Maintenance Condition (A), No Anchors**

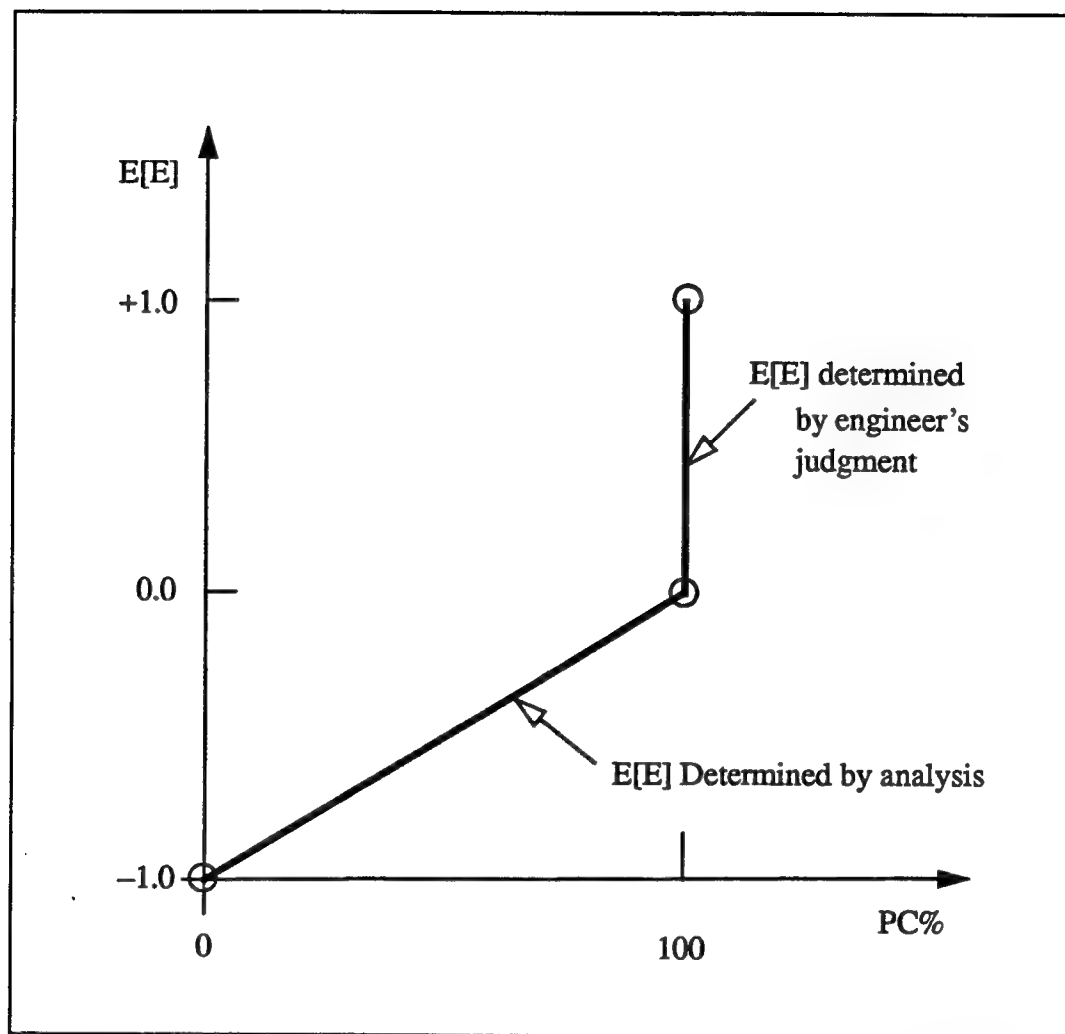
**Figure 3.3 Relationship between  $E[E]$  and Percent Base in Compression**

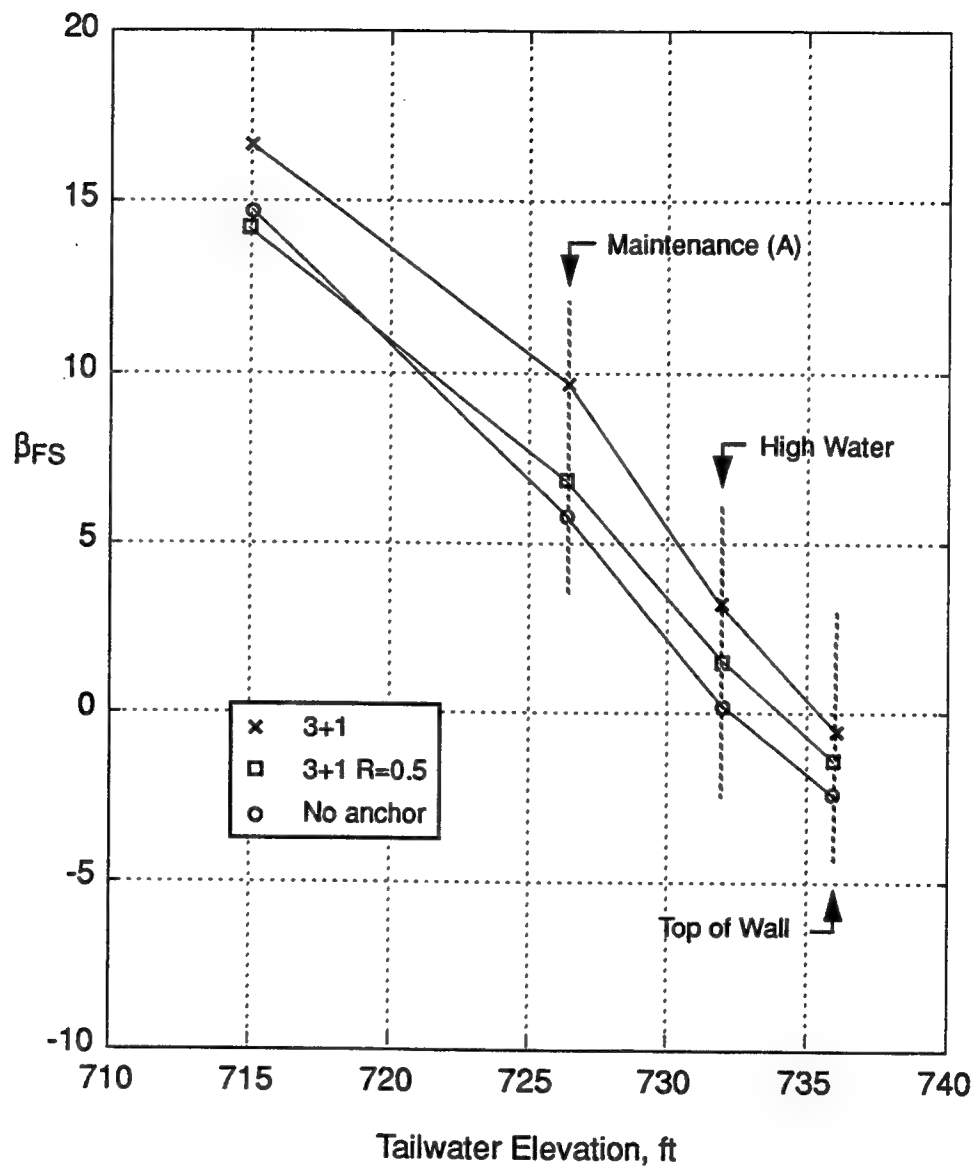
**Figure 3.4 Locks and Dam No. 3, Monolith M-20,  $\beta_{FS}$  versus Tailwater, Resultant Location Analysis, Maintenance Condition (A)**

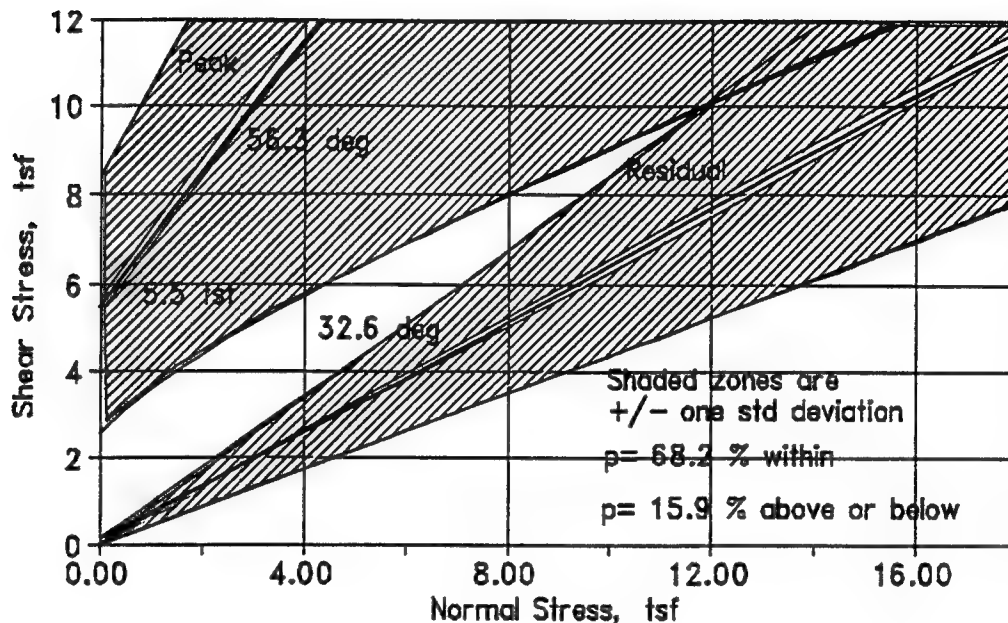
Figure 4.1 Probabilistic Strength Envelopes, Locks and Dam No. 3

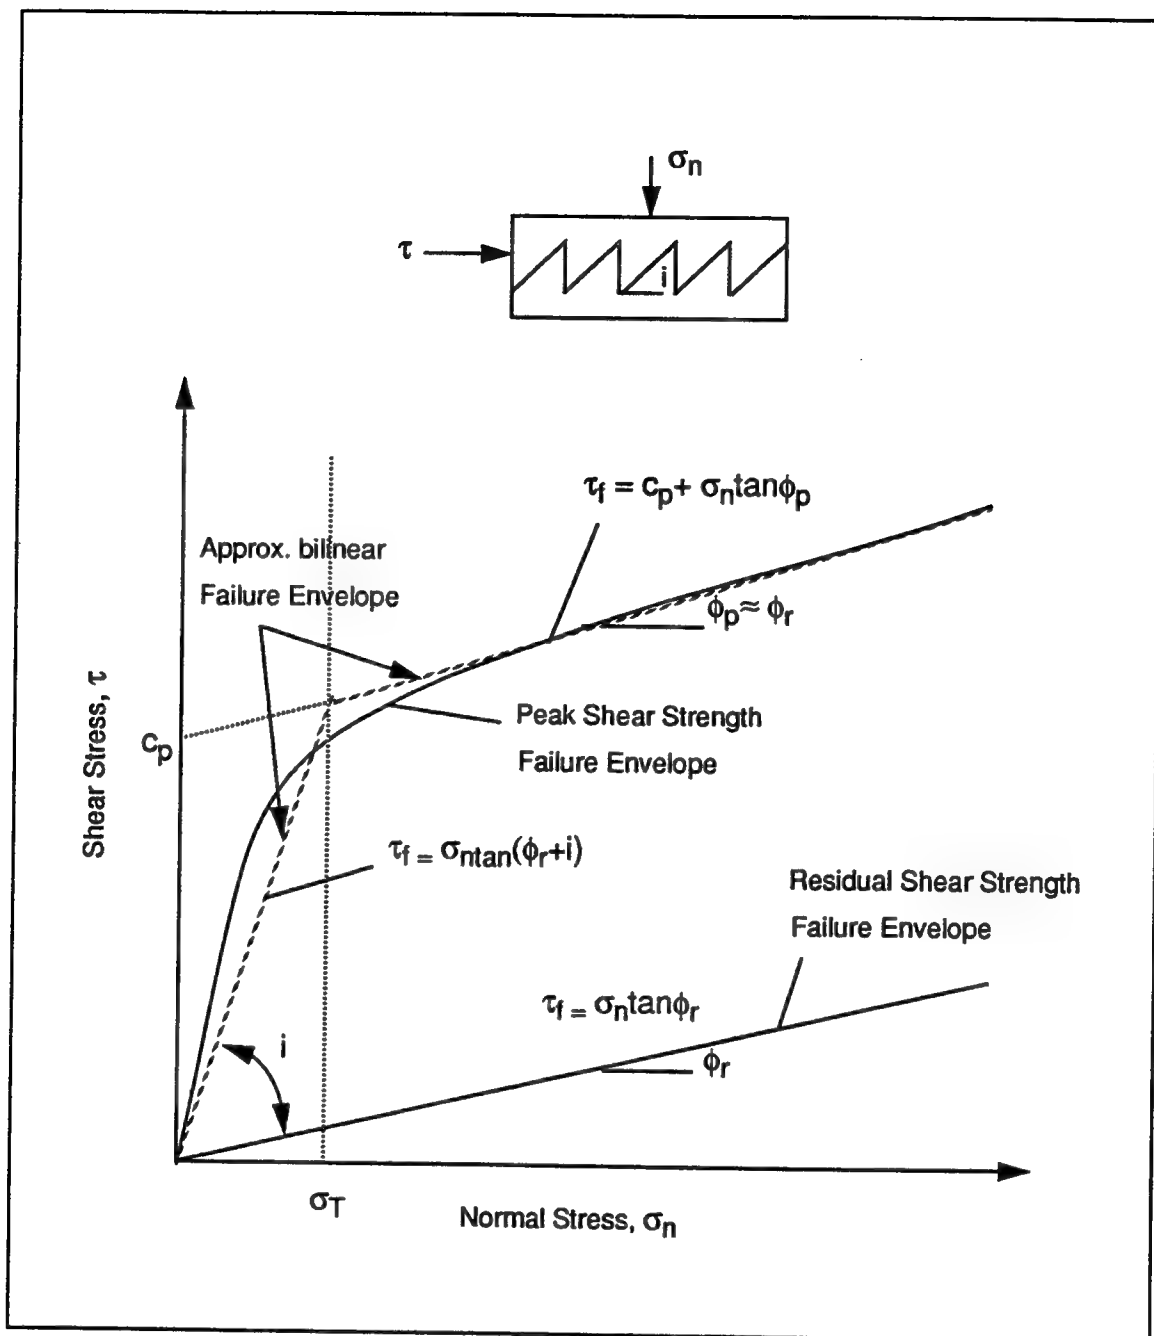
**Figure 4.2 Typical Curvilinear Failure Envelope and Bilinear Approximation for Modeled Discontinuous Rock**

To further clarify the issue of use of peak or residual strength, the literature on rock strength was reviewed, specifically the report by Nicholson (1983) for WES, a paper by Underwood (1976), former chief geologist of the Corps of Engineers, and a paper by Deere (1976). The shear behavior for discontinuous rock described by these references is illustrated in Figure 4.2. For discontinuous rock, the failure envelope is

typically curvilinear, but can be approximated as bilinear. The irregularities along rock joints (or the foundation) can be characterized by an interface angle  $i$  which produces an additional frictional shear resistance over and above the residual strength at low normal stresses as the strongly cohesive rock components must slide up and over each other to fail in shear. At normal stresses greater than  $\sigma_T$ , failure occurs through intact rock pieces and the cohesion of the intact rock governs the failure conditions. According to Deere, the  $i$  angle is often in the range of 5 to 15 degrees but may be as high as 30 to 40 degrees for very irregular jointing.

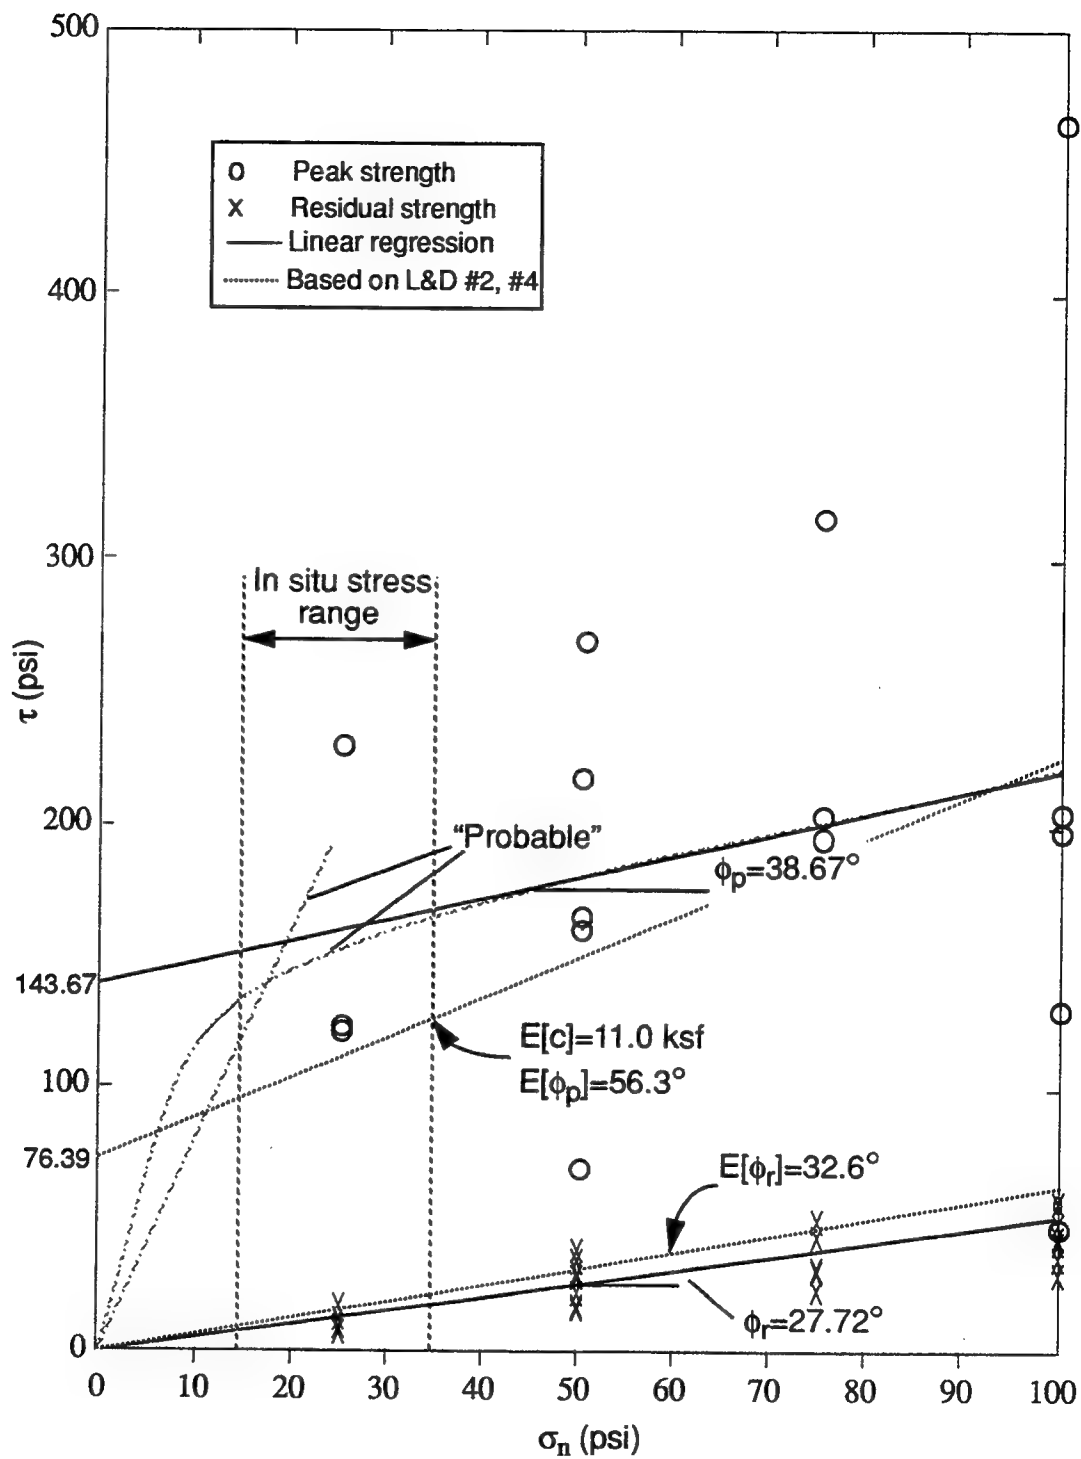
Figure 4.3 Locks and Dam No. 3, Shear Strength from Direct Shear Test Results

This curvilinear strength envelope concept is superimposed on data from the Monongahela River materials in figure 4.3. The circles marked "peak strength" and the x's marked "residual strength" represent results of the recently-furnished 1977 direct shear testing under monolith M-20; the solid lines represent the results of regression analyses on that data; and the dotted lines represent the expected values used in the previous report. The actual effective stresses at the base of the monolith are in the range 2.0 to 5.0 ksf (14 to 34 psi). In reviewing this figure, it is apparent that, if the foundation consists of broken rock components, foundation stresses may be low enough that the irregularity angle  $i$  may still be contributing some frictional resistance. In this case, the previous "MSU" peak strengths are somewhat conservative and not unreasonable. If, in fact, the foundation is smooth or contains a horizontal, previously sheared surface, the "Pittsburgh" or "MSU" residual strengths are appropriate. It should be recalled that, in all cases, it is implied there is a 0.5 probability that the strength is below any expected value selected.

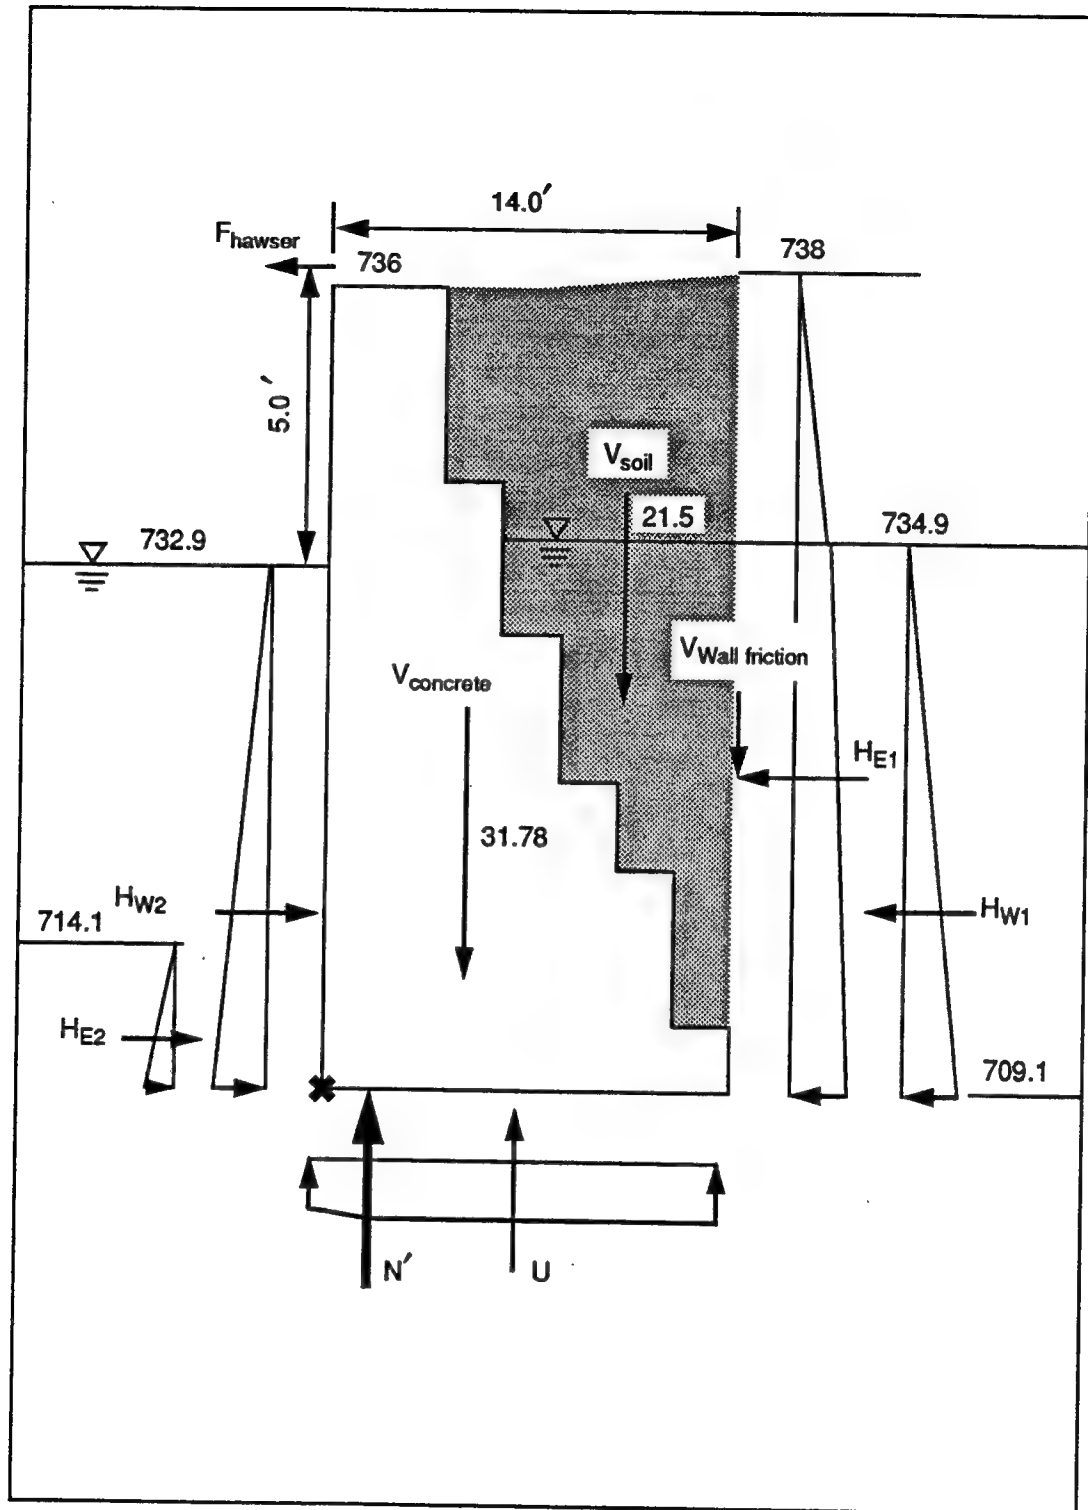
Figure 5.1 Locks and Dam No. 3, Monolith L-8, Free Body Diagram

Monolith L-8 is an approach wall monolith at Locks and Dam No. 3. In the previous report, it was selected for analysis because its relatively small width-to-height ratio causes its effective base resultant force to lie outside the kern. Furthermore, the earth backfill contributes uncertainty in the horizontal normal force and vertical shear force transmitted to the structural wedge. A cross-section and free-body diagram for the monolith is shown in Figure 5.1
